## OXFORDSHIRE BUILDINGS RECORD REPORT OBR.44

### Queens Row, Grove Street, Wantage

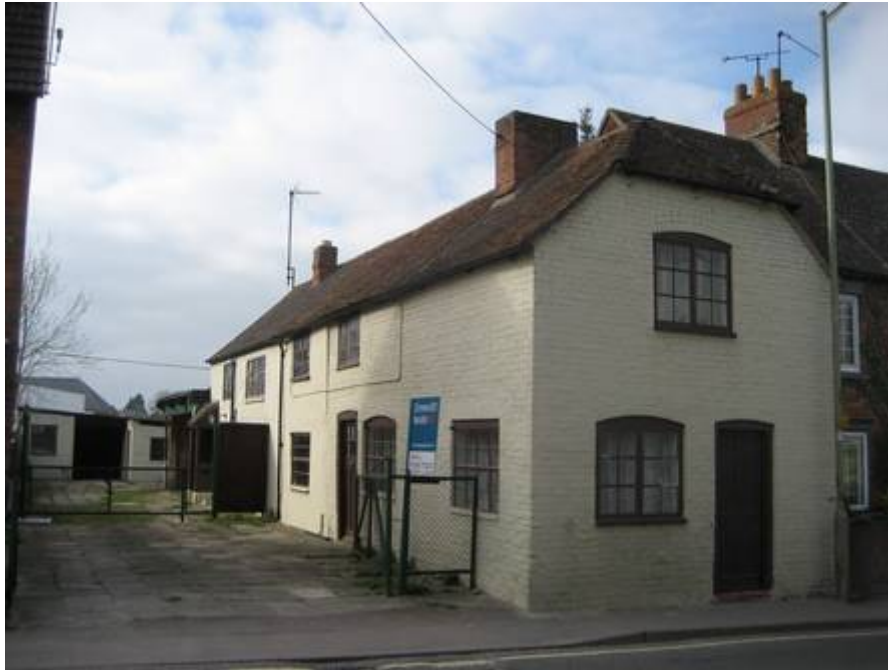
Figure 1 Queens Row, Grove Street, Wantage

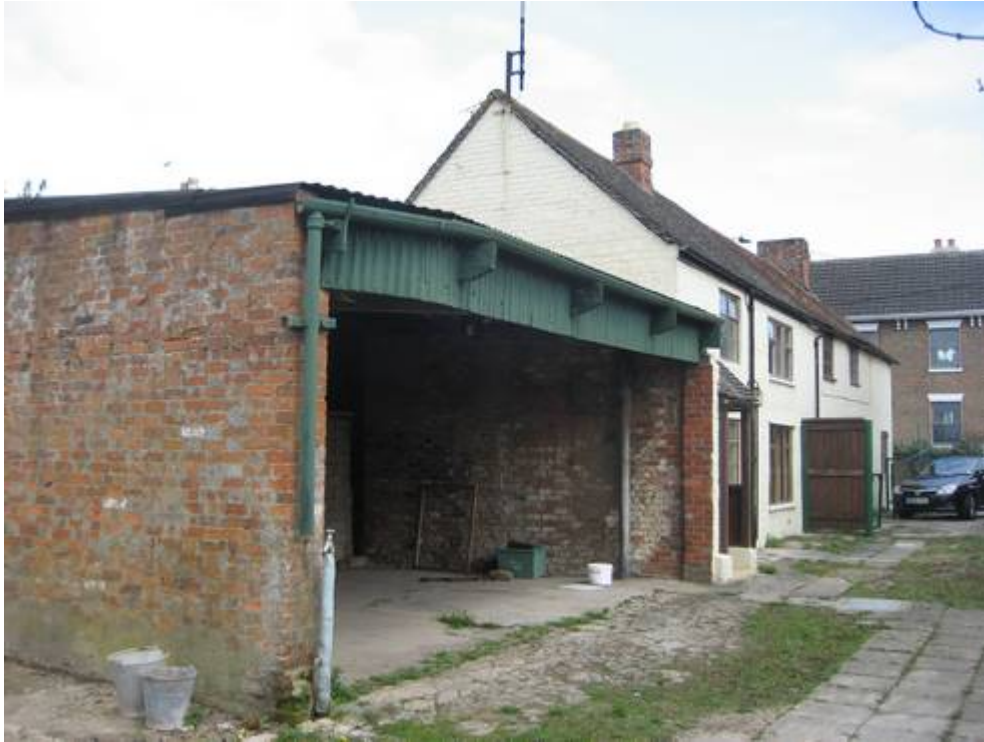
Figure 5 shows where two of the cottages were replaced by an open shed or garage.

**Figure 5** Garage in foreground built on foundations of a cottage pair

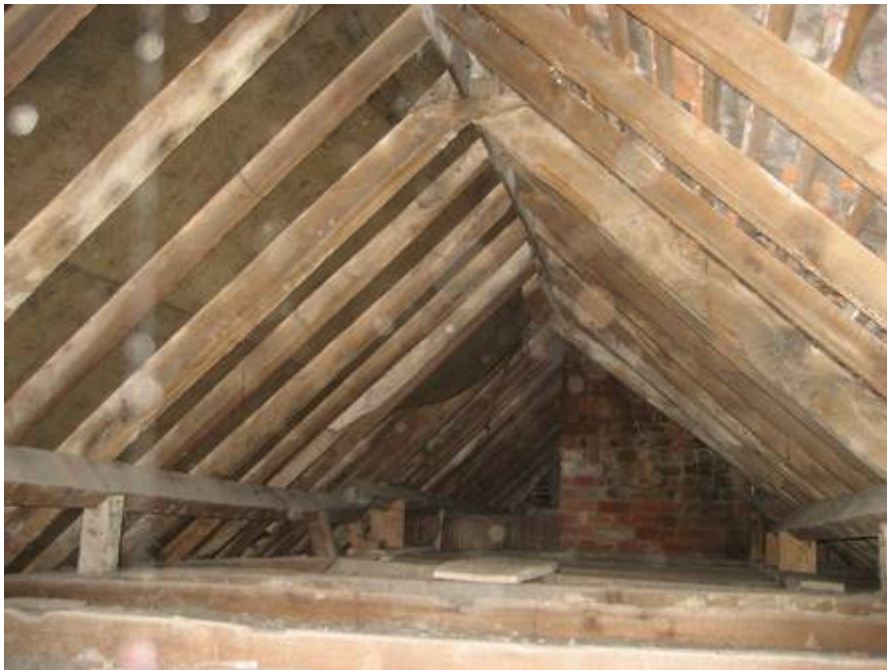
Although there are significant differences in layout and construction (external wall thicknesses vary between the cottages) the internal walls are mostly stud partitions, and there are no party wall gables between the cottages (see figure 6 showing the roof space looking east).

**Figure 6** Roof space looking east

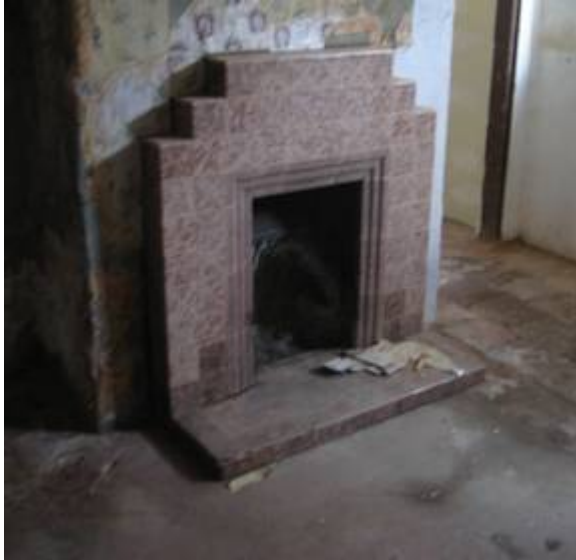
The building history is complex, as many additions and alterations were made by the family of the present owner when it was used as part of a scrap and general dealer's business. Mr Rowles remembers much of this history, such as brick thicknesses, beams put in by his father, alterations to the staircases, the position of former doorways, and the provenance of features such as a 1950s fireplace from Swindon (figure 7).

**Figure 7 1950s fireplace from Swindon**

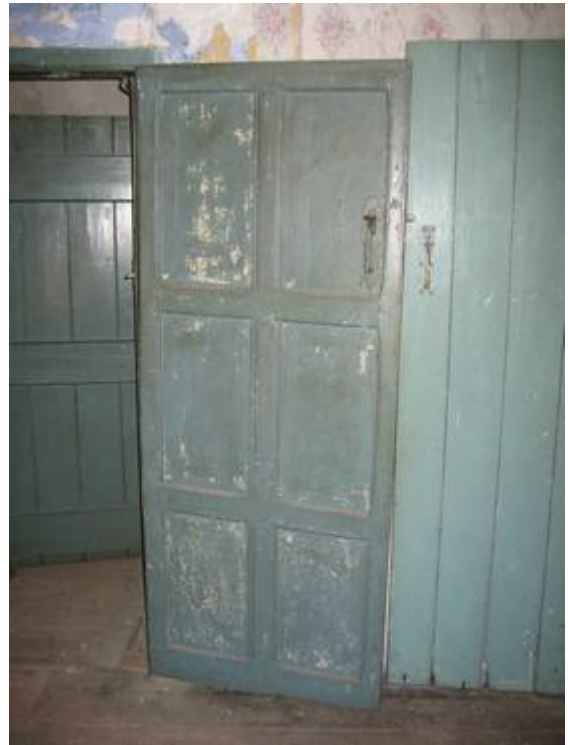
The internal doors are mostly of plain planks with Suffolk latches (no baseplates). One, however, is 17<sup>th</sup> century, but hung upside down. It has rails with paired pegs and run-out mouldings, small panels, but the dust ledge is at the top of the panel rather than at the foot (figure 8)

**Figure 8 Internal doors in central cottage - a plank door on the right, and 17th century panelling on the left - both with Suffolk latches.**

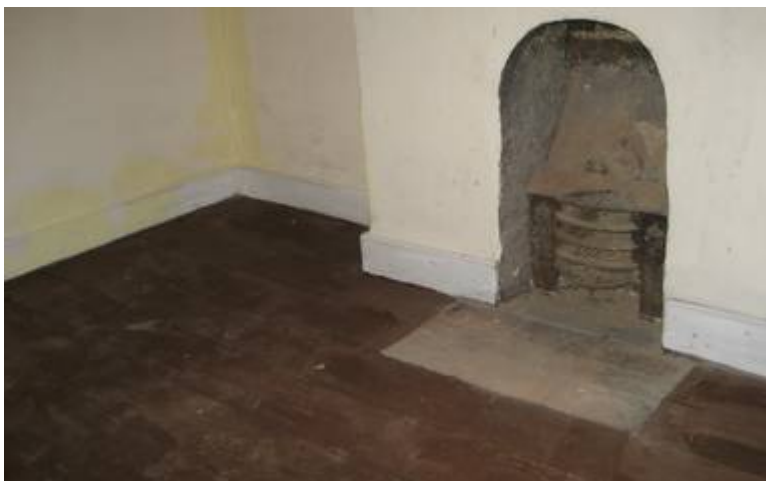
There are two stacks, one between the rooms of the front cottage serving four fireplaces, although only one of these has a grate *in situ* (figure 9). The other stack is between the last two cottages, where there were fireplaces to each of the ground floor rooms. There was also apparently a stack serving the ground and first floor rooms of the central cottage, but this has been removed.

**Figure 9 Fireplace in upper front room**

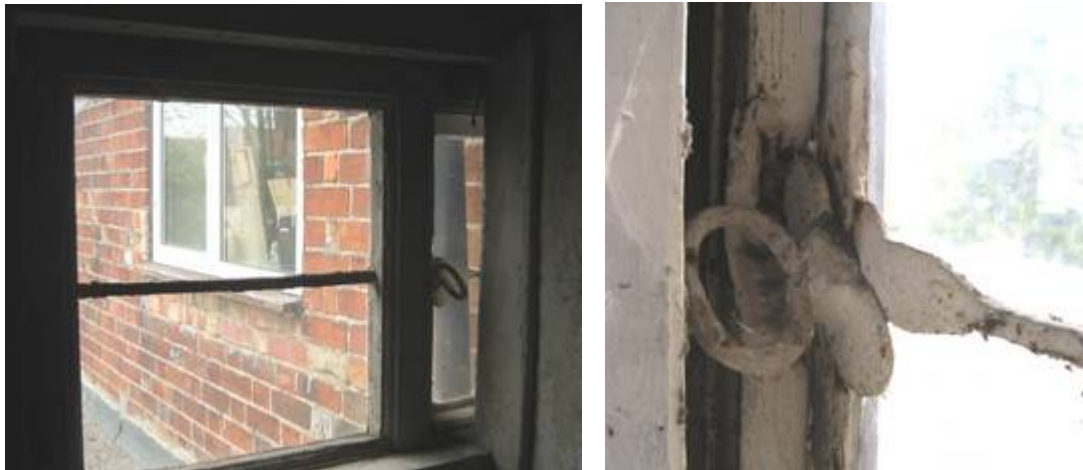
Although most of the fenestration is modern – some even consisting of metal windows laid on their sides – there is one small window to the rear (north) elevation (figure 10) with a turnbuckle catch. Although such catches can be found from the late 16<sup>th</sup> century onwards, the design is similar to one noted in a house of 1849 in Wiltshire (Hall (2005) p.90). The window itself seems much later, however.

**Figure 10 Window in rear wall and turnbuckle catch**

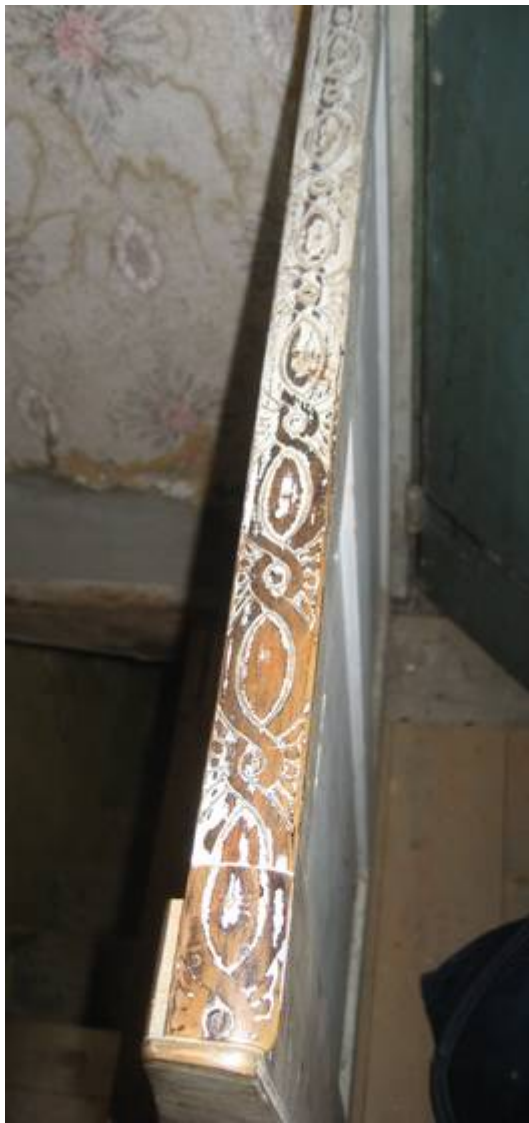
At the top of the central stairs – which had at some point been moved – was an unusual carved rail shown in figure 11.

**Figure 11 Carved rail at the top of the central stairway -the stairs are to the left, the landing to the right.**

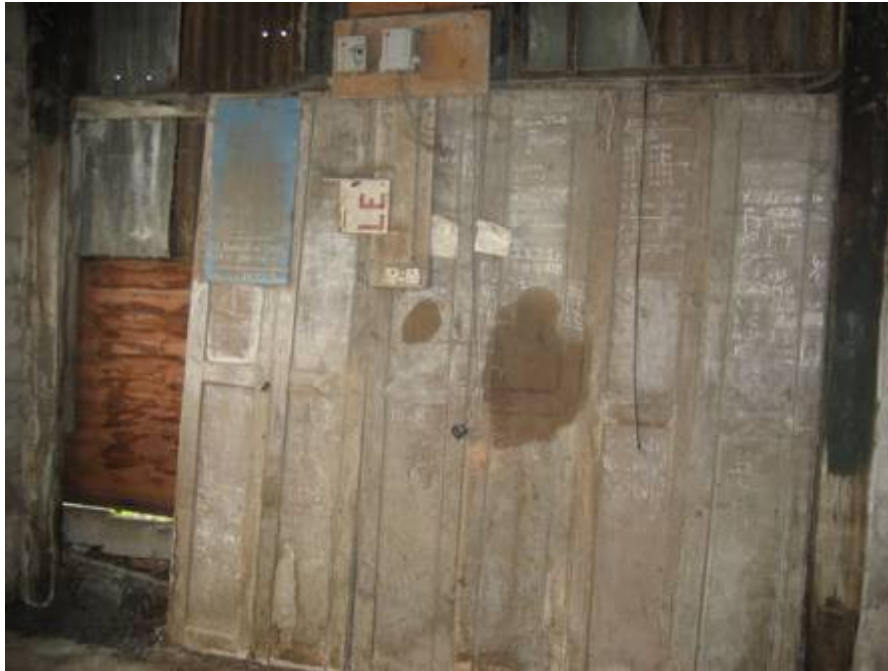
To the rear of the plot is a further garage-type building, now empty, but which at one time covered a manufacturing facility for concrete products. A set of old doors shown in figure 12 still has the prices of various items chalked up.

**Figure 12 Doors with concrete item prices**
